Weekly Construction Report

Hatchery Creek Design/Build Project

Week:	October 12-18, 2014	Project No:	1305
Rain Days/Weather Conditions:	Rained a total of 2.7" from Sunday to Thursday this week (Burkesville gauge).		
Personnel on-site:	<i>EcoGro/Ridgewater:</i> John Arthur, Tom Cutter, Chad Relinski, Brad Redmon, & Russ Turpin. <i>Stantec:</i> N/A		
Equipment on-site:	Komatsu PC 160 w/ hyd. thumb, PC 360 w/ hyd. thumb, Terex TA27, Bobcat T300		
Material deliveries to project site:	<ul style="list-style-type: none"> N/A 		
Work performed this week:	<ul style="list-style-type: none"> Sieved 12"+ rock from previously sieved rock (6"+) at Disposal Area. Approximately 2000 cubic yards of rock were sieved. No other work was performed this week due to the rain. 		
Erosion & sediment controls installed:	❖ N/A		
Work scheduled for next week:	<ul style="list-style-type: none"> ⚡ Continue excavating for floodplain and channel upstream of Campground Road (113+00 to 116+80) and haul clay to ravine. ⚡ Finish compacted clay fill in ravine stream crossing ~Sta. 106+00 to 106+60. ⚡ Build ravine rock spillway. ⚡ Continue delivering boulders for step pools and start delivering 18" D50 rock for step

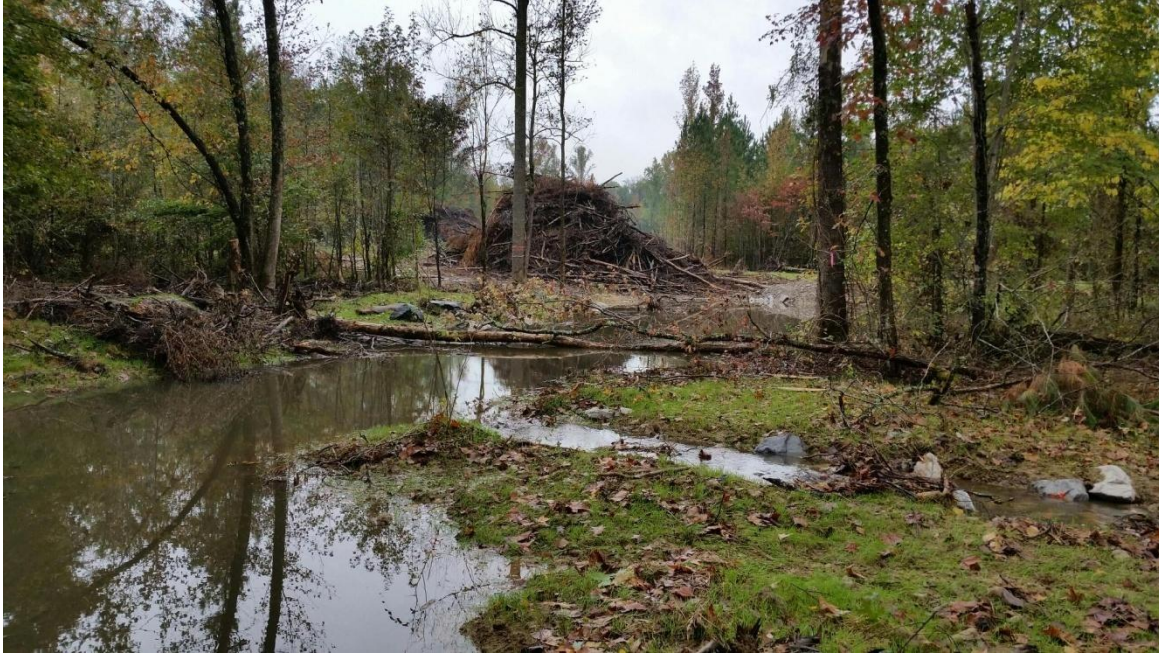
Section of completed channel (looking upstream/south from ~ Sta. 128+50). Tributary 9 Spillway is to the right of picture.

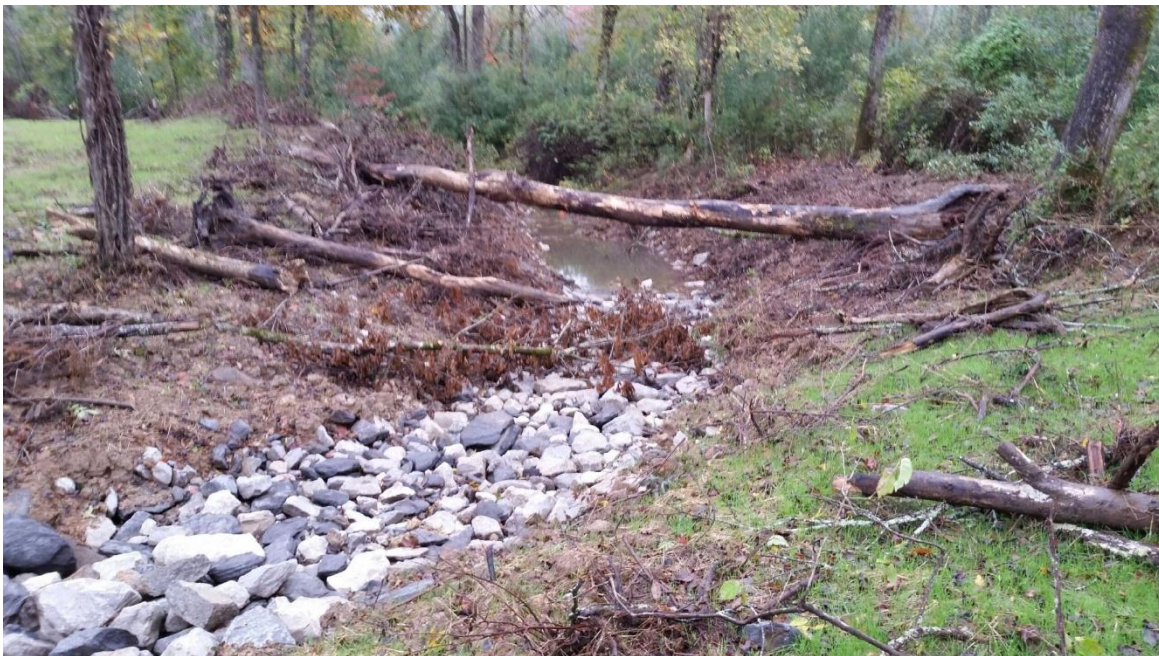
Looking down the Tributary 9 Spillway (looking west from ~ Sta. 128+50). There is already enough flow through the spillway to maintain perennial flow in Tributary 9, as can be seen at the end of the spillway in the middle of the picture.

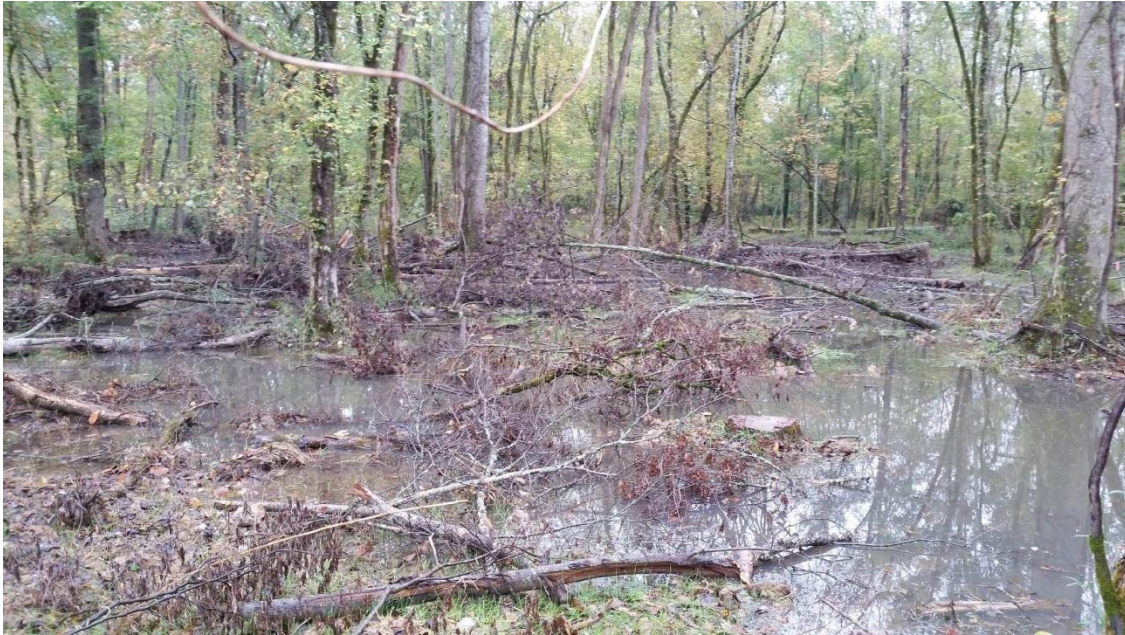
Section of D (braided) channel in the middle of temporarily impacted and enhanced areas of wetlands (looking southeast at ~Sta.138+50). Water is currently flowing into this area from Tributary 9 and is only flowing out via the Tributary 9 spillway at ~LT Sta. 128+00.
